MachineryWatch.Com, Inc. Case History

| Machine: | 80 Kilowatt Standby Generator |
| Industry & Location: | Manufacturing, Michigan |

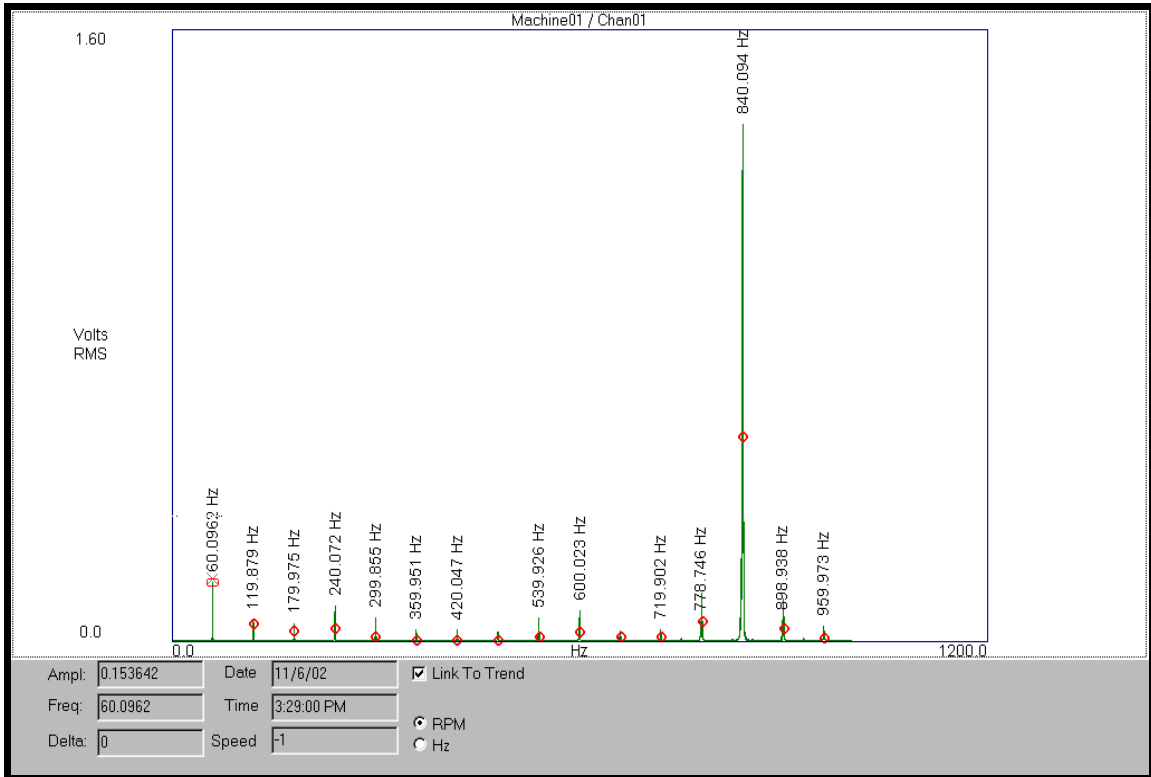
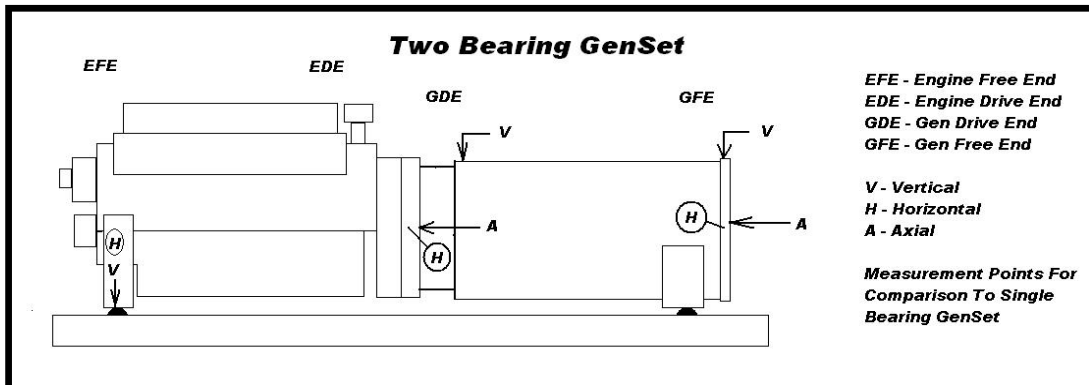
To determine if torsional natural frequencies were excited, a spectrum/sideband analysis was performed on the signal generated from the 14 generator fan blades as they passed a photocell. The high-resolution spectrum is included along with the “zoom” view of the data that clearly shows sidebands spaced at 1.5X RPM (90 Hz). The sidebands are caused by torsional vibration of the rotor.

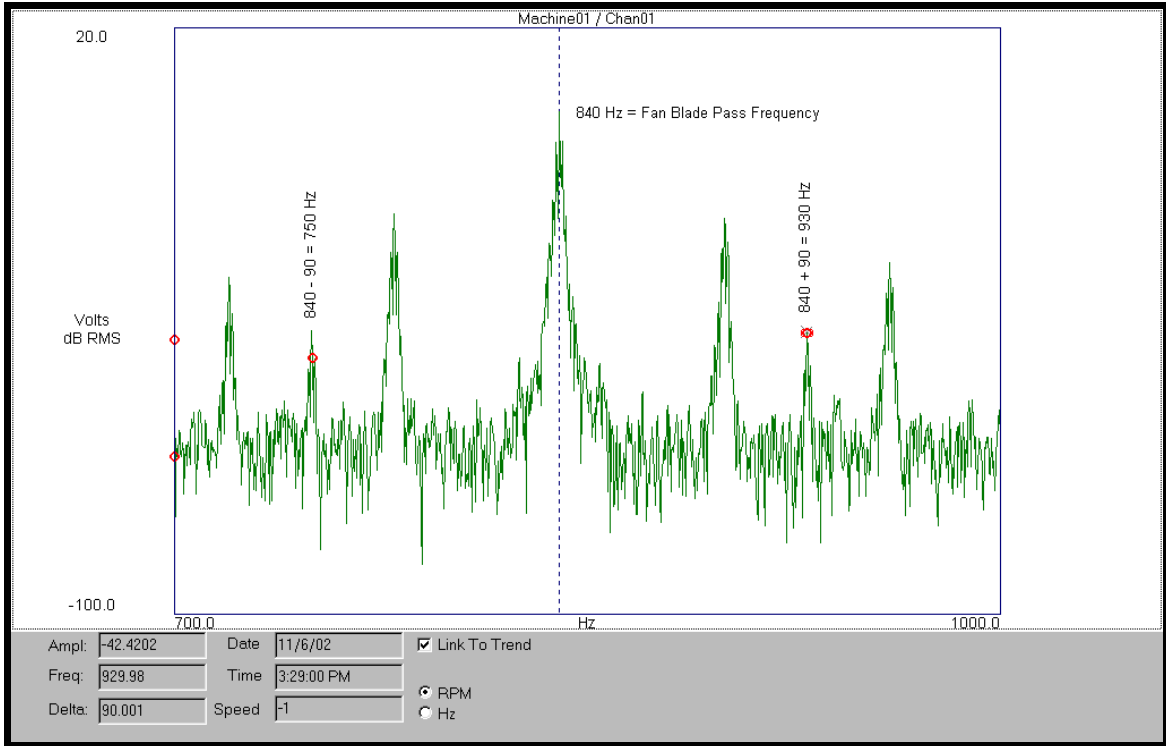
The initial readings were taken on the generator set with a full range of load conditions. The outboard end of the generator generated the highest vibration amplitudes in the vertical direction due to 1X RPM sources and was not load dependent. The horizontal direction vibration was dominated at low loads by 1X RPM vibration but was dominated by 1.5X RPM vibration at high loads.

1.5X RPM Vibration (Vel.) Amplitudes
Versus Load, Before and After
Outboard Gen. Big Horiz. Direction

The new rotor configuration was tested in February. Results showed that the 1X RPM vibration on the generator was significantly reduced in the vertical direction as a result of the balancing. The natural frequency of the rotor assembly was also shifted away from the 1.5X RPM frequency sufficiently to reduce the 1.5X RPM vibration amplitude significantly. The rotor/stator contact problem was eliminated.
