# **Identification of a Gearbox problem on an Overhead Crane**

## Introduction

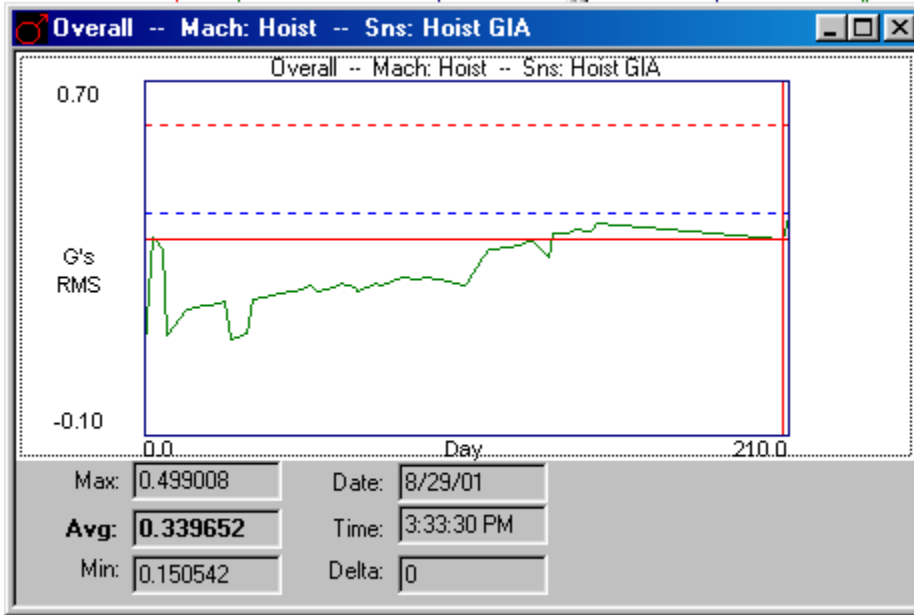
Figure 1 Trend of GIA from 2/20/01 to 8/30/01

Note that the overall value of the vibration for this point was trending up over the period of time from when the system was installed (2/20/01) to 8/30/01. Figure 2 shows a spectrum for the GIA measurement point on 2/28/01 and the same measurement point for 9/4/01 is shown in Figure 3.

In early September 2001 we recommended to the plant to inspect/repair or replace the gearbox. The gearbox was replaced during a planned outage that took place between 9/7/01 and 10/8/01. Figures 6 and 7 show the trends for the same two analysis parameters with data through 10/19/01.

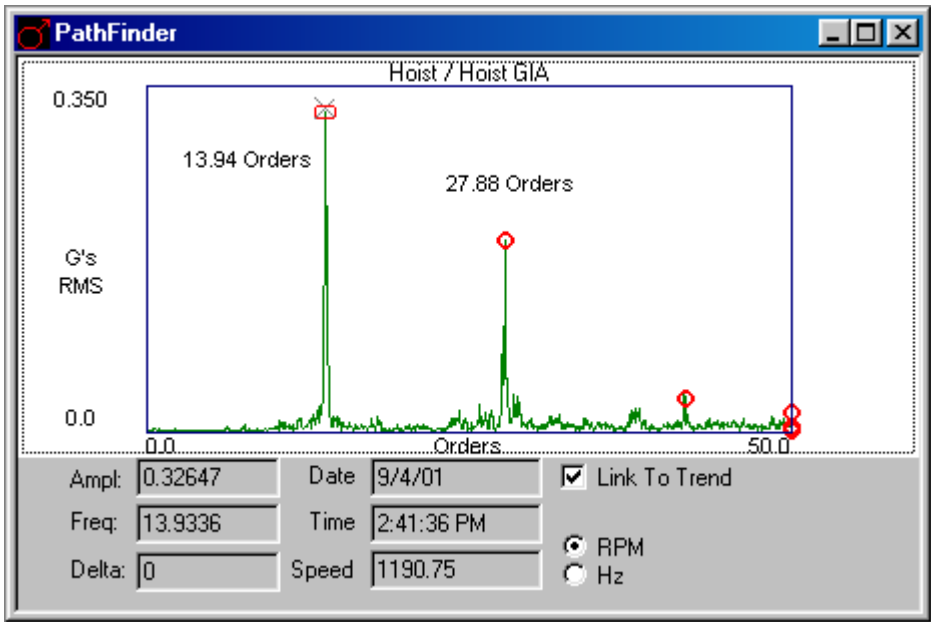
**Figure 3 Spectrum for GIA on 9/4/01**

Clearly there is a significant increase in vibration at 14 and 28 times the motor speed between these two dates. As it turns out, the number of teeth on the input shaft of the gearbox is 14. Using a feature built in to the MAARS software, we added 2 analysis parameters to the database to define the 1X and 2X input gearmesh frequency and then had the software go back and calculate trends for these parameters from the data stored in the database. Figures 4 and 5 show these trends.

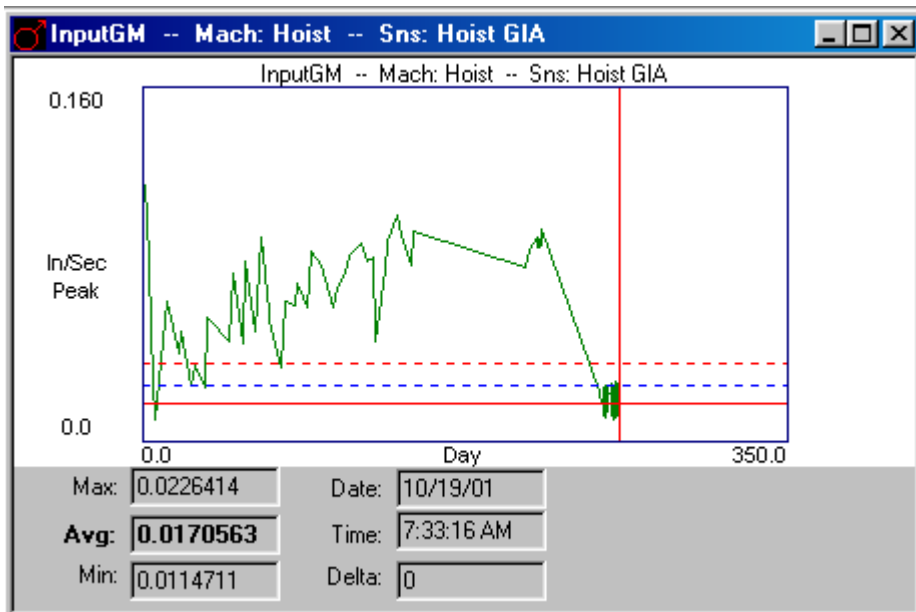
**Figure 6 Input Shaft Gearmesh**

It is clear from these trends that the replacement of the gearbox reduced the vibration levels to the original levels. Subsequent inspection of the removed gearbox revealed a damaged bearing on the input shaft. The gearbox replacement took 4 days.
