MachineryWatch.Com, Inc. Case History

Machine: Large Propylene Process Refrigeration Compressor
Industry & Location: PetroChemical, Louisiana
Equipment: Gas Turbine Driven, 5 Stage Centrifugal Compressor
Power Turbine and Compressor Speed = 5,700 RPM
Instrumentation: MAARS Model 5000, factory installed proximity probes
Condition: Rotor Bow from Inter-stage Seal Rub
Indication: Failure to Achieve Operating Speed, Trip When Passing Critical Speed, Excessive 1X Amplitudes on all Probes
Corrective Action: Compressor Disassembled, All components dynamically balanced above critical speed, Spacers between wheels modified to prevent creation and retention of bow due to rub-induced thermal bow

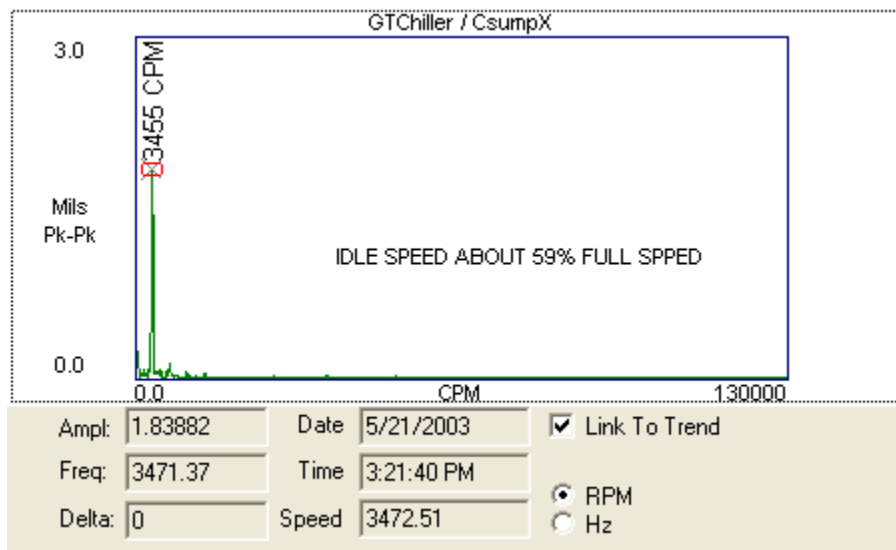
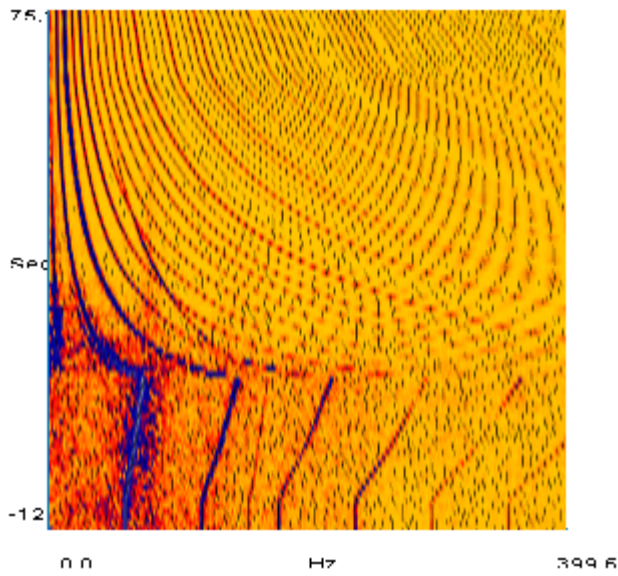
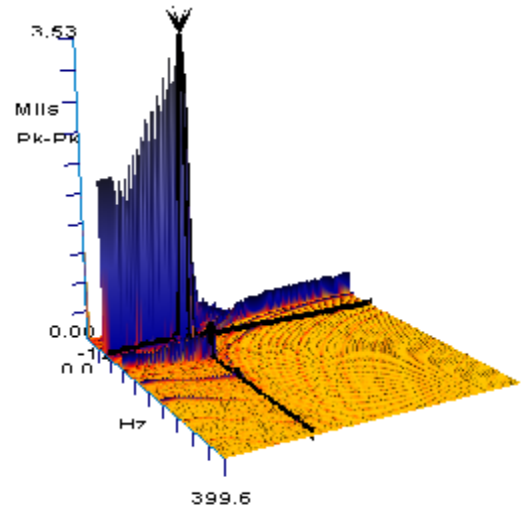
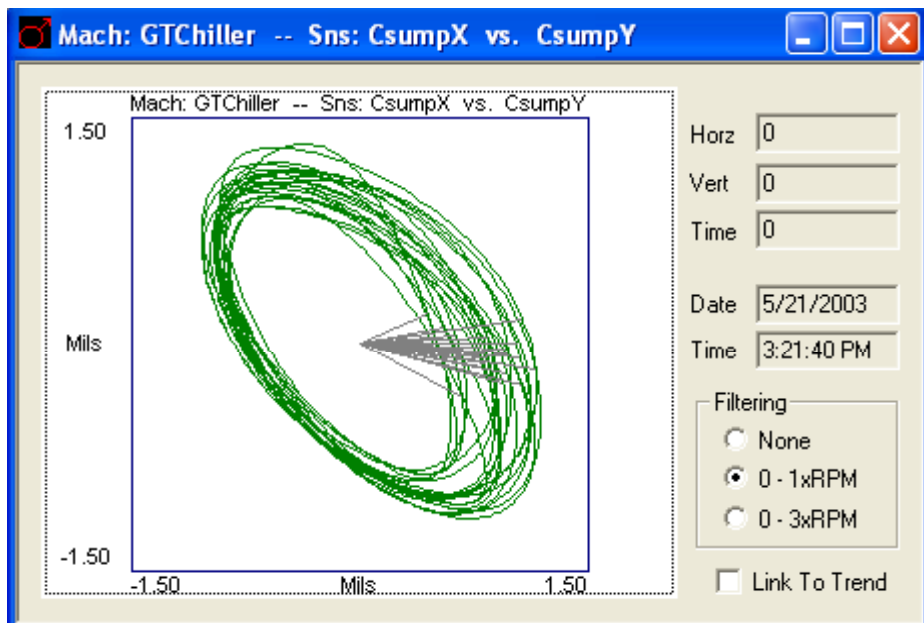
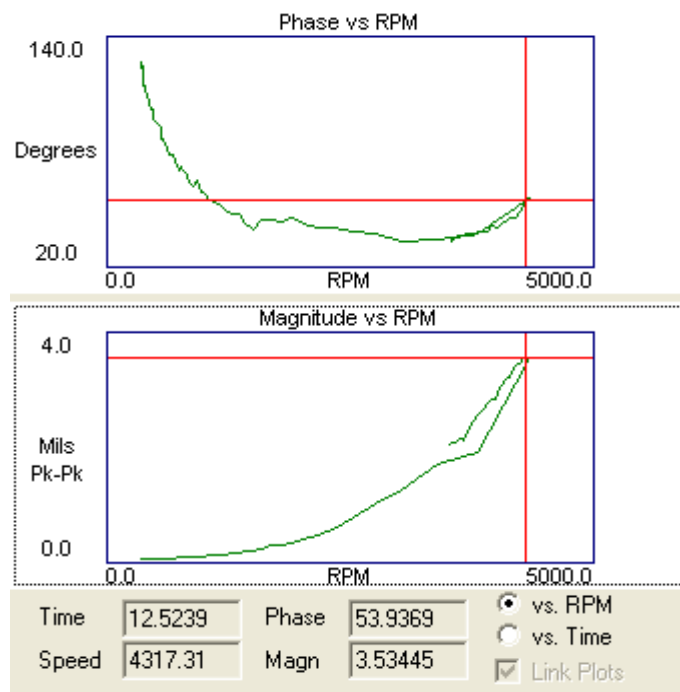
The problem got worse with each successive start of the machine so that soon even when idling at about 50% of design RPM the vibration level approached the manufacturer's recommended alarm levels. The orbits did not indicate on-going rub conditions.

The spectral data all indicated that the controlling frequency at all probes was 1X RPM. Evidence of the rub of the interstage seal was discovered as the machine was disassembled and a careful review of the clearance measurements made during assembly indicated that a below

minimum clearance was overlooked during assembly.

After the high speed dynamic balance on a balance stand in Houston, the unit was reassembled and levels were well within the compressor manufacturer's recommendations.
