MachineryWatch.Com, Inc. Case History

Machine:	Vertical Pump Motor
Industry & Location:	Water Treatment Plant, Virginia
Equipment:	Long Drive Shaft, Centrifugal Pump, Wound Rotor Variable Speed Motor, 6'4" above base, Motor Speed = 540 RPM
Instrumentation:	MAARS Model 5000, accelerometers
Condition:	Looseness induced Resonance at 1X RPM
Indication:	Excessive Vibration (Shaking) at 1X RPM, resonance verified with transient capture, coast-down and impact tests
Corrective Action:	Tightened Motor Hold Down Bolts 1/16 to 1/4 turn
Results:	Vibration reduced at 1X RPM by approximately 67%. To further reduce levels the speed of the pump was going to be slightly reduced to provide further separation of the natural frequency and the running speed.

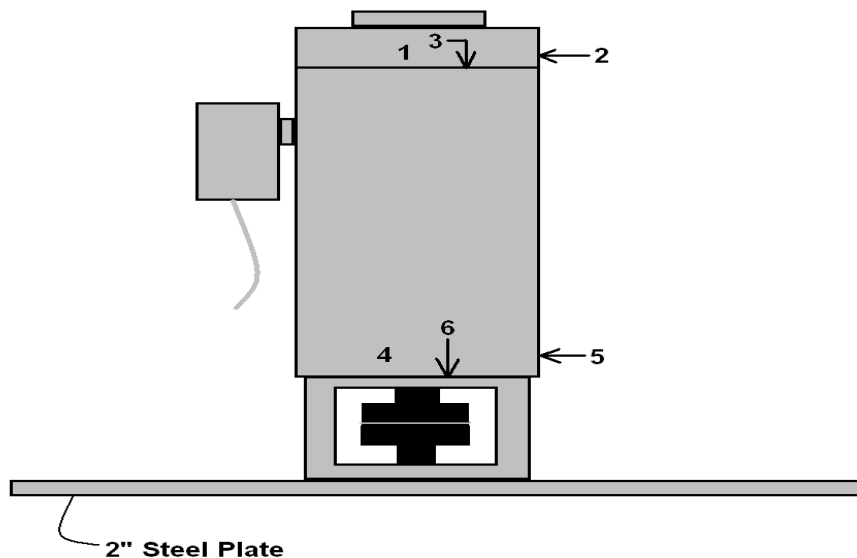
The subject pump motor had been recently overhauled by a local shop. When the site personnel reinstalled the motor there was excessive vibration felt and viewed. The repair shop and facility requested an analysis be performed to determine the source of the vibration.

The vibration tests that showed the vibrations were highest at the top of the motor and very directional. These are characteristics of vertical pump resonances. The spectral data also showed a clear large amplitude peak at 3600 CPM (60 Hz), which is also typical for these motors. Both impact tests and

uncoupled coast down tests were used to verify the natural frequency.

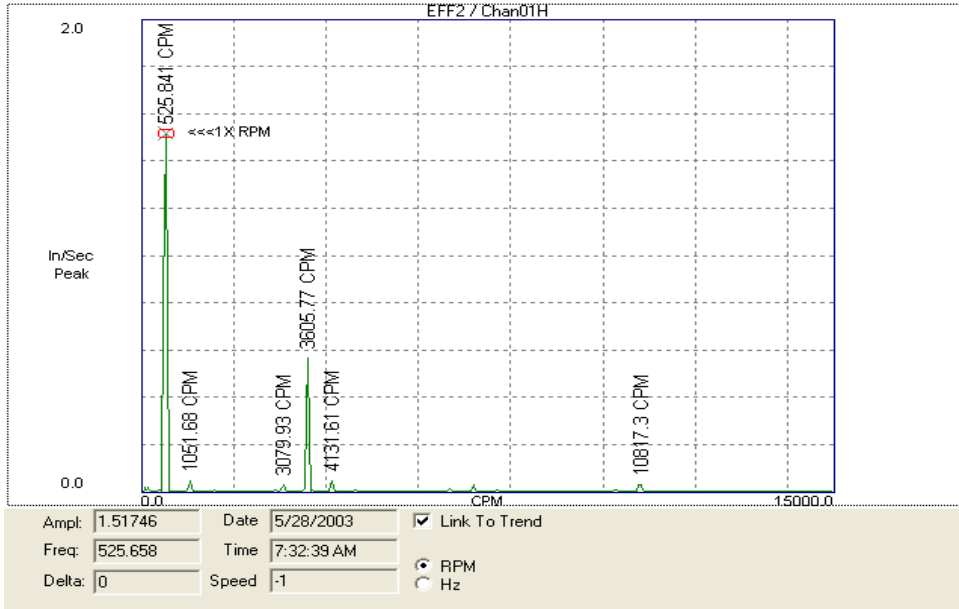
More bump tests were done after the bolts were tightened and the results are shown in the spectra above via the higher response frequency (591 CPM vs 539 CPM). Another proof of the shifted natural frequency is shown below in the coast-down waveform captured before tightening the bolts. The highest amplitude spectra captured during this and the coast-down captured after the bolts were tightened follow the displayed waveform. The spectra showing the higher frequency peak was captured after the bolts were tightened.
