MachineryWatch.Com, Inc. Case History

Machine:	Vertical “Canned” Safety Injection Pump
Industry & Location:	Nuclear Power Generation, Virginia
Equipment:	Motor Driven (250 HP), Long (40') Drive Shaft and “Turbine” Pump, Motor Speed = 1781 RPM
Instrumentation:	MAARS Model 5000, accelerometers
Condition:	Piping and Motor Base Resonance, Turbulence, Whirl
Indication:	Excessive sporadic amplitude at 46% of RPM, Impact tests
Corrective Action:	Recommended reinstalling damping braces that had been disconnected, and altering conditions used for testing to reduce turbulence.

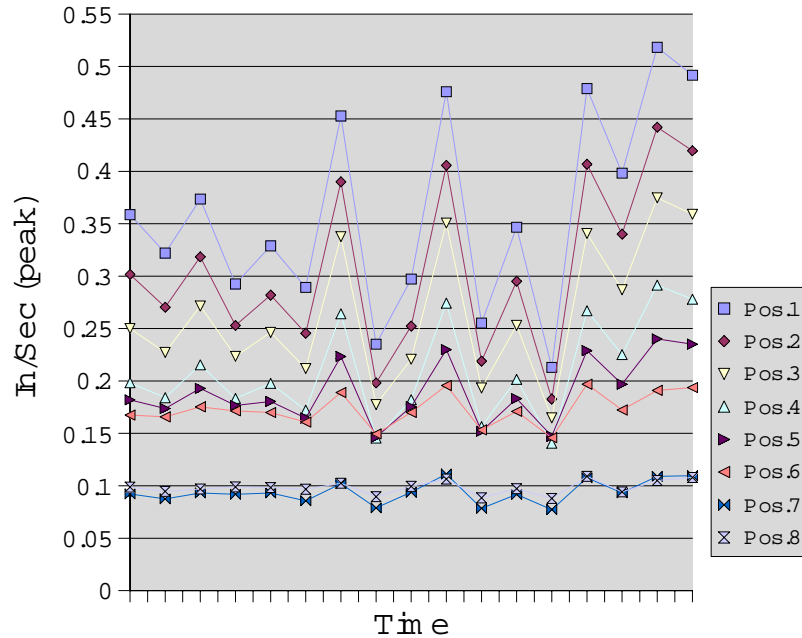
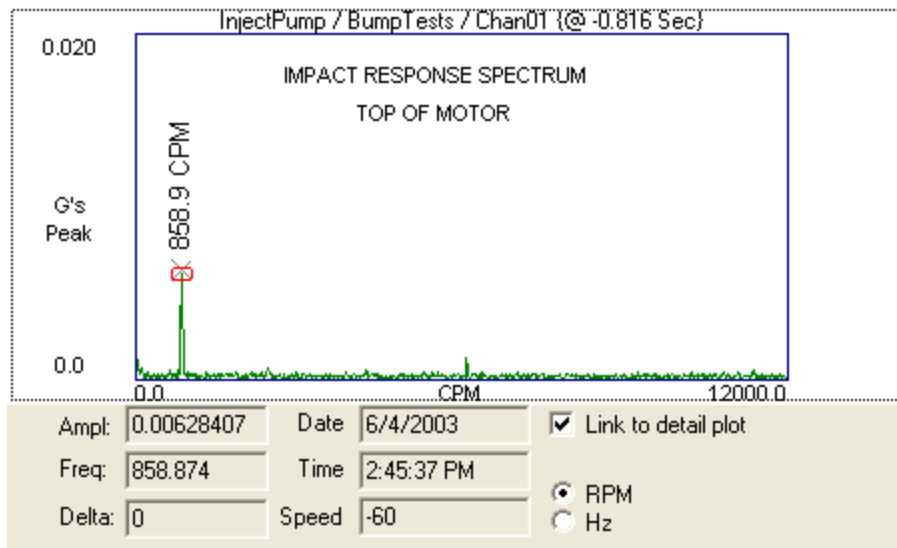
Overall Vibration

The data oscillations are clearly visible in the included chart of overall vibration

levels at all measurement conditions over the period of a few minutes. A sketch of measurement positions is included. The piping and motor itself are shown to have a natural frequency in the area of 46% of running speed. This natural frequency, the tendency to whirl and the broadband variable energy of turbulent flow create an unpredictable excitation cycle in the vibration levels, causing the levels to cycle in and out of alarm.

The recommendations included reattaching the seismic damping braces and some modifications to make for more uniform testing conditions in terms of flow velocities so that velocities in all piping will be uniform. This will allow better comparisons to be made of one pump to another. Also it was recommended that the pipe supports be added to the 2" recirculation line which was also found to be resonant at 46% of running speed. Support was not provided for this pipe in accordance with standard piping handbook guidelines.

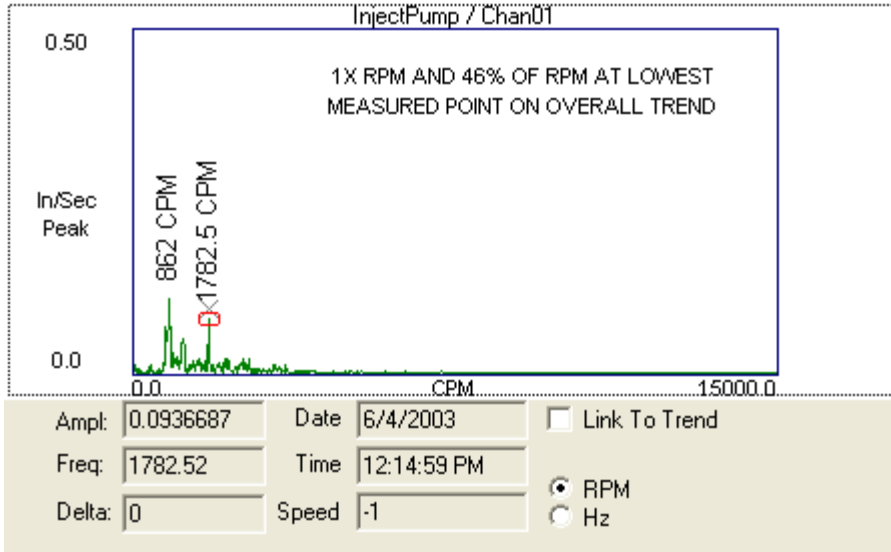
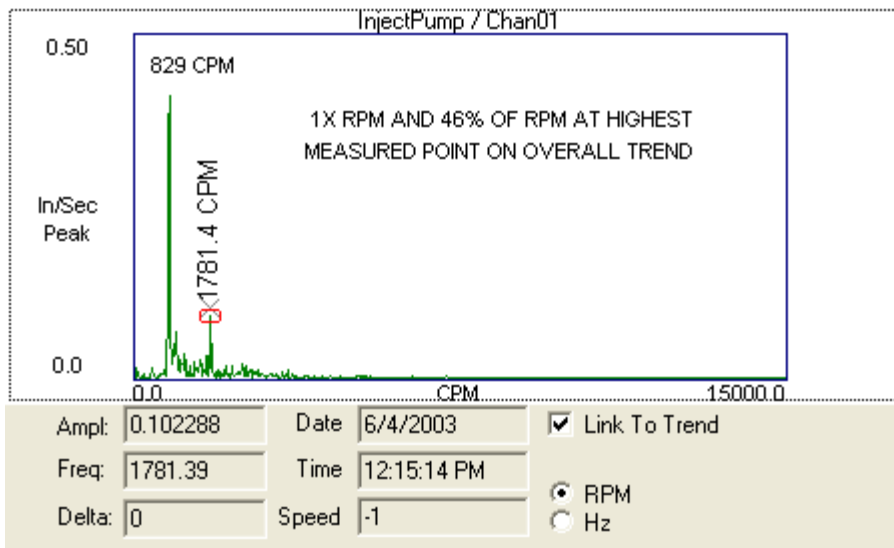
A review of data collected by the site personnel and provided before arrival indicated that all the excessive vibration energy was centered around 46% of RPM. This coincides with the whirl frequency tendency of vertical pumps.

This is how the vibration varied over a period of 1.5 minutes.
