MachineryWatch.Com, Inc. Case History

| Machine: | 80 Kilowatt Standby Generator |
| Industry & Location: | Manufacturing, Michigan |

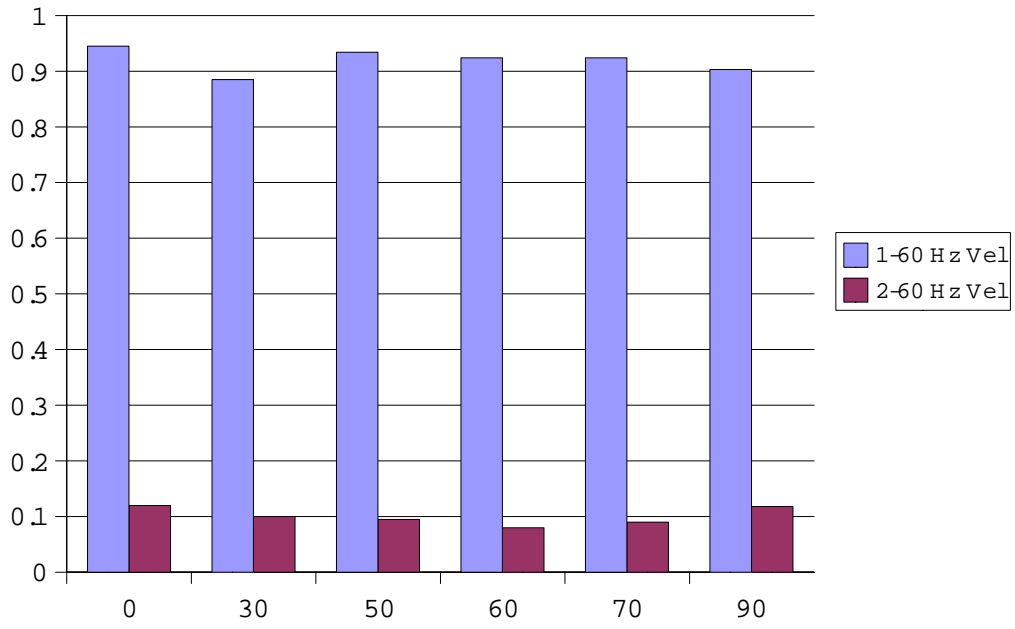
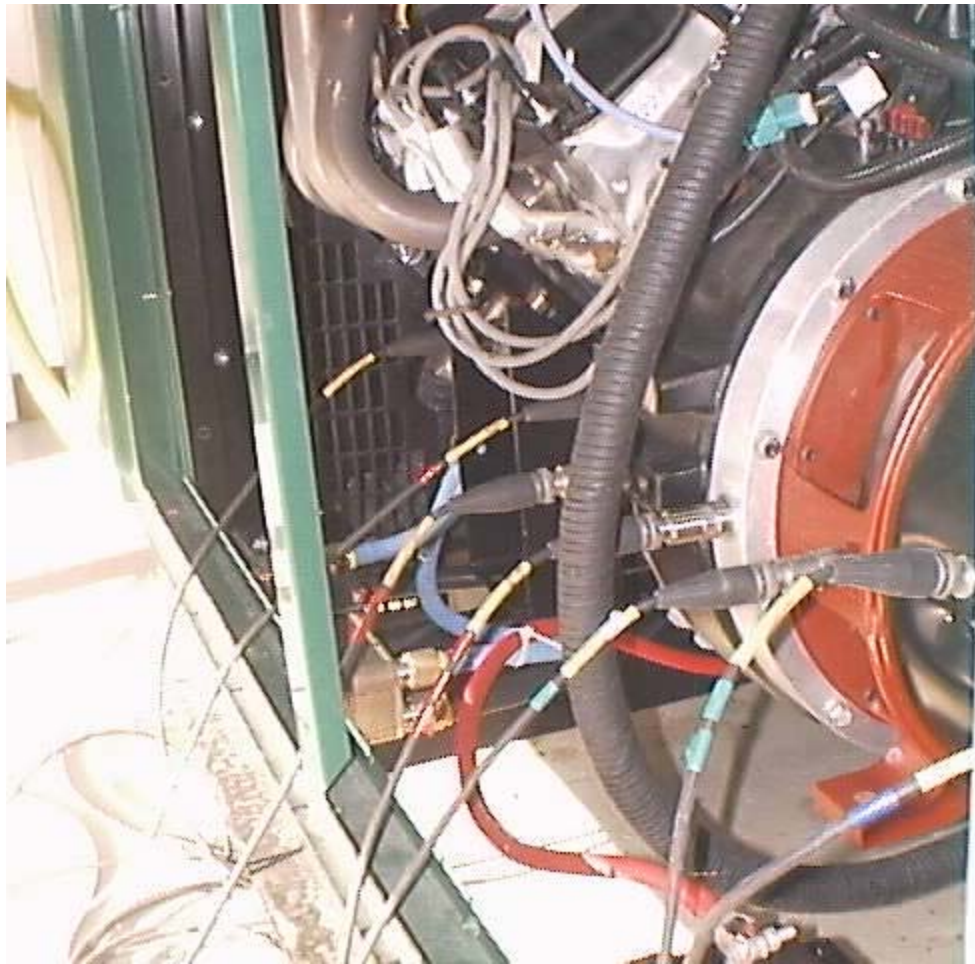
To determine if torsional natural frequencies were excited, a spectrum/sideband analysis was performed on the signal generated from the 14 generator fan blades as they passed a photocell. The high-resolution spectrum is included along with the “zoom” view of the data that clearly shows sidebands spaced at 1.5X RPM (90 Hz). The sidebands are caused by torsional vibration of the rotor.
