MachineryWatch.Com, Inc. Case History

Machine:	Vertical Pump Motor
Industry & Location:	Water Treatment Plant, Virginia
Equipment:	Long Drive Shaft, Centrifugal Pump, Wound Rotor Variable Speed Motor, 6'4" above base, Motor Speed = 540 RPM
Instrumentation:	MAARS Model 5000, accelerometers
Condition:	Looseness induced Resonance at 1X RPM
Indication:	Excessive Vibration (Shaking) at 1X RPM, resonance verified with transient capture, coast-down and impact tests
Corrective Action:	Tightened Motor Hold Down Bolts 1/16 to 1/4 turn
Results:	Vibration reduced at 1X RPM by approximately 67%. To further reduce levels the speed of the pump was going to be slightly reduced to provide further separation of the natural frequency and the running speed.

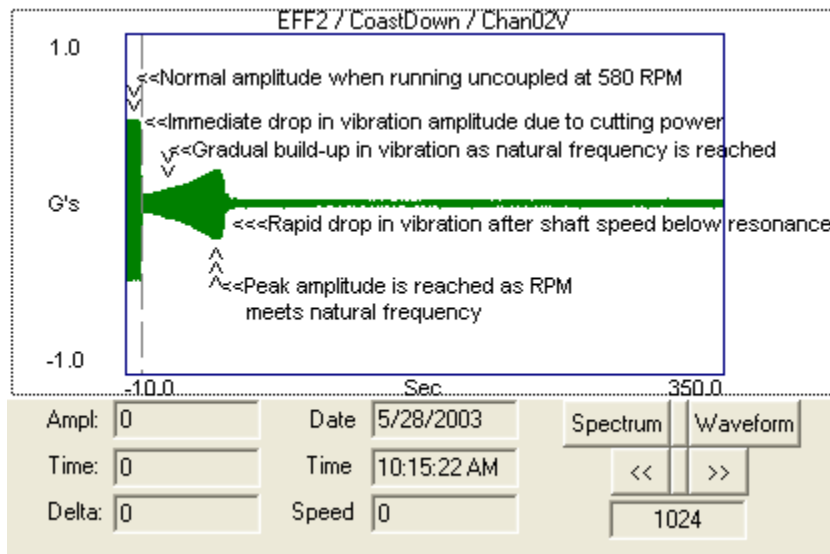
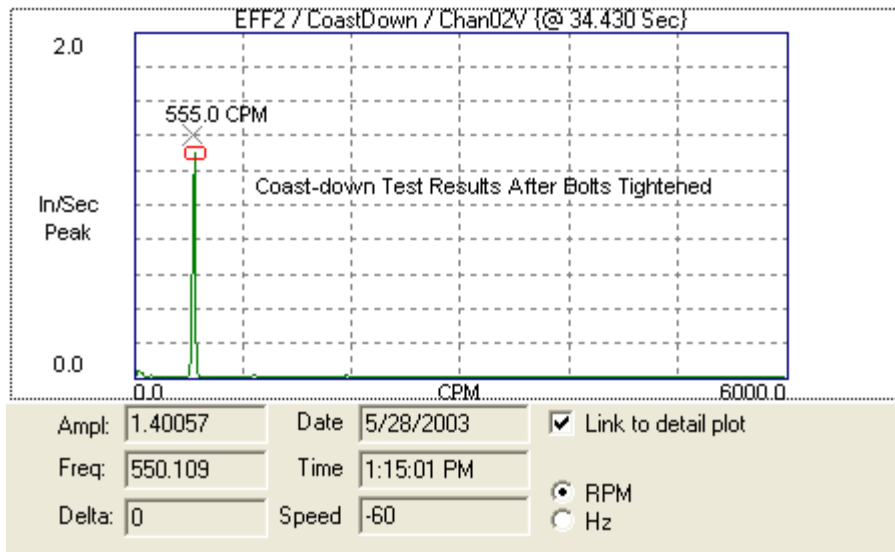
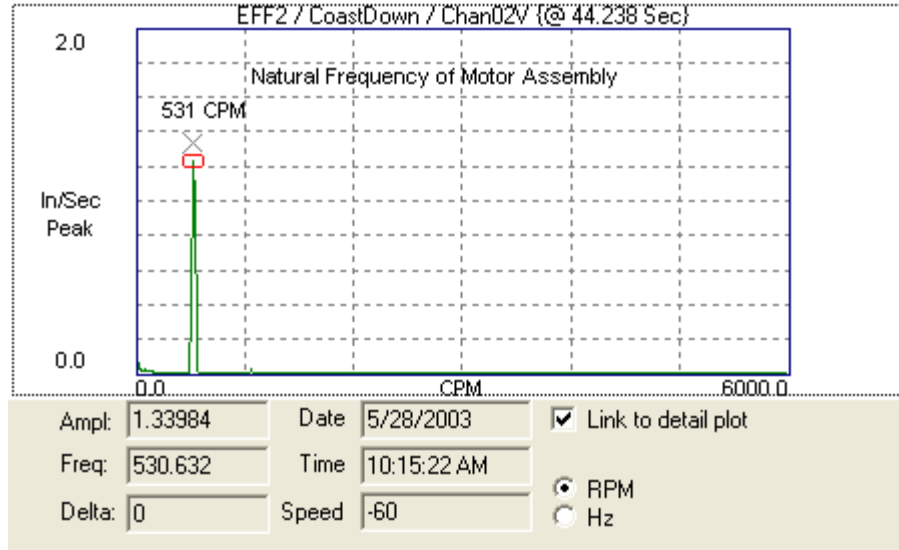
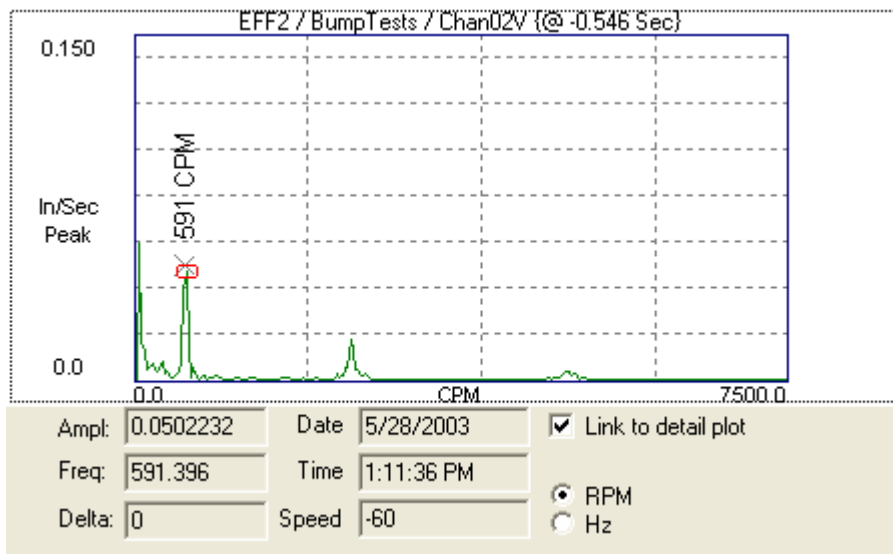
The vibration tests that showed the vibrations were highest at the top of the motor and very directional. These are characteristics of vertical pump resonances. The spectral data also showed a clear large amplitude peak at 3600 CPM (60 Hz), which is also typical for these motors. Both impact tests and

More bump tests were done after the bolts were tightened and the results are shown in the spectra above via the higher response frequency (591 CPM vs 539 CPM). Another proof of the shifted natural frequency is shown below in the coast-down waveform captured before tightening the bolts. The highest amplitude spectra captured during this and the coast-down captured after the bolts were tightened follow the displayed waveform. The spectra showing the higher frequency peak was captured after the bolts were tightened.
